# Recovery of Petroleum Brine-Contaminated Soil by *Eleocharis* sp. in a Tropical Marshland

Abstract: Almost all research on natural attenuation and phytoremediation of sites contaminated with briny produced water has been conducted in temperate climates, however, there is a dearth of information on the use of tropical species for this purpose. It is within this context, that we investigated a spontaneously growing hypersaline spikerush from a contaminated site in southeast Mexico, to determine its soil salinity limits, the relationship between soil organic matter and salinity, and for preliminary documentation of floristic succession with Typha sp. for phytoremediation of brine spills. Soil was sampled (0 cm-20 cm) three times between 2018-2021, focusing on the end of the dry season (most critical period). The species tentatively identified as *Eleocharis mutata* was tolerant to soil hypersalinity (Electrical Conductivity: 125 dS/m) and appeared to generate a cyclic process of succession to recover areas with soil salinity levels higher than it could otherwise tolerate. A salinity gradient was found between the most heavily contaminated part of the site ("kill zone", > 212 dS/m),

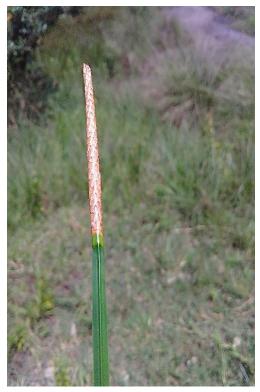
Figure 2: Close-up of an individual of Eleocharis sp. found at the study site.

The selected species has been described in the introduction. It will be described more detail in the results section. The species was tentatively identified using the key presented by Angelo *et al.* (2020), confirming by comparison to photographs from the same source (Fig. 2).

According to historical studies made by García-López *et al.* (2006), this area was previously dominated by *Typha* sp. before the construction of the petroleum processing complex. This spikerush (*Eleocharis* sp.) had stems with a triangular cross section (triquetrous), and superior seed packets, slightly larger in diameter than the stem, with cartilaginous floral scales. This was differentiated from other genera of Cyperaceae since it had a triquetrous stem (often associated with the genus *Cyperus*), but not the typical inflorescence composed of spikes supported by three peduncles. Furthermore, of the species with the kind of seed packet observed, and with the triangular cross section, there are only two species reported for the region, and only one of these is found in saline environments. It was identified using the key presented by Angelo *et al.* (2020), confirming by comparison to photographs from the same source. In Fig. 2, a close-up is shown of an individual of *Eleocharis* sp. found at the study site.

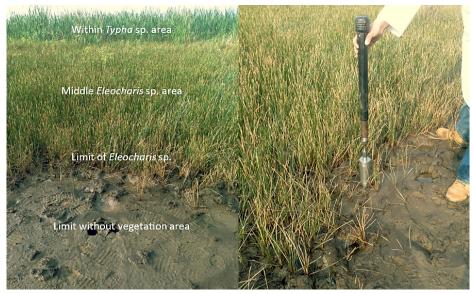
**Figure 4:** Transition from the zone without vegetation in the foreground to the zone dominated by *Typha* sp. (at left). Sampling at the growth limit of *Eleocharis* sp. (at right). Photographs from 2021.

Table 1 shows the sampling dates and a description of some of the details observed during sampling. Fig. 1 is a reconstruction of the scenario at the site affected by soil salinity but taking into account features observed in the different samplings, because each sampling had its particularities. In the 2018 sampling, around the area without vegetation, dry *Eleocharis* sp. specimens were found, and this area extended to the west. In 2021 the area shown for *L. hexandra* (more predominant in 2019), was only a line, with the kill zone more open to the east. In the 2019 sampling, several individuals of *Typha* sp. were found to be advancing north of the major *Typha* sp. stand (denoted in Fig. 1 as a dashed line). In the 2021 sampling, the *Typha* sp. had almost advanced completely to this line in a solid stand. Fig. 3 shows sampling conditions from the 2021 sampling.

The results of parameters of the soil in the third sampling are show in the Table 4, and graphically in Figs. 4 and 5.
